## Repair Standards

### 01-020 – Utility Tall Bottom Rail Repairs

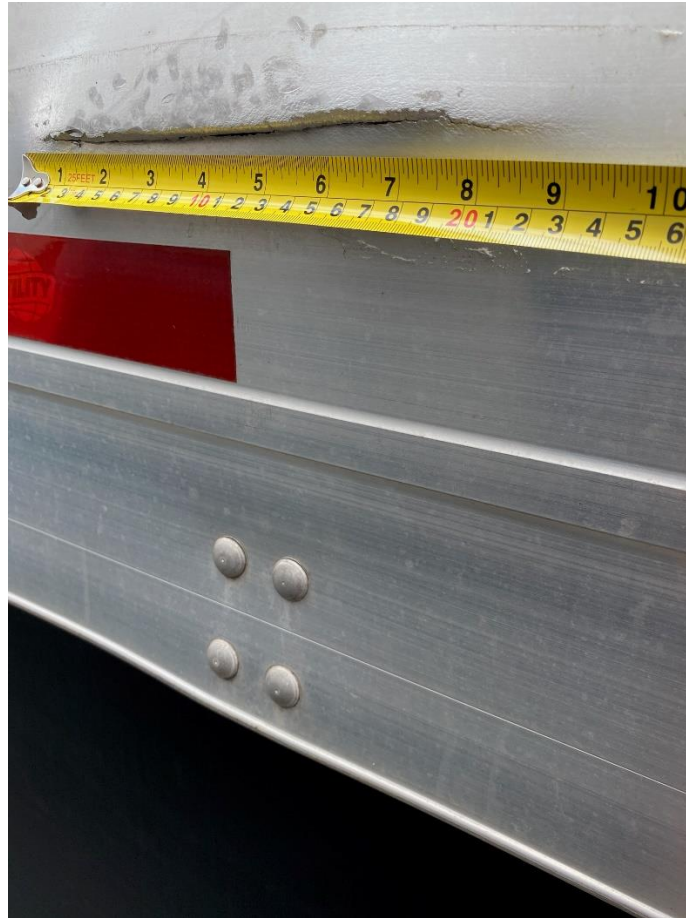
## TBR Needing Replaced

**Note:** The area is greater than 6" and the bend is greater than  $\frac{3}{4}$ ". The TBR will need replaced per OEM standards.

1. Replace Tall Bottom Rail to OEM standards.

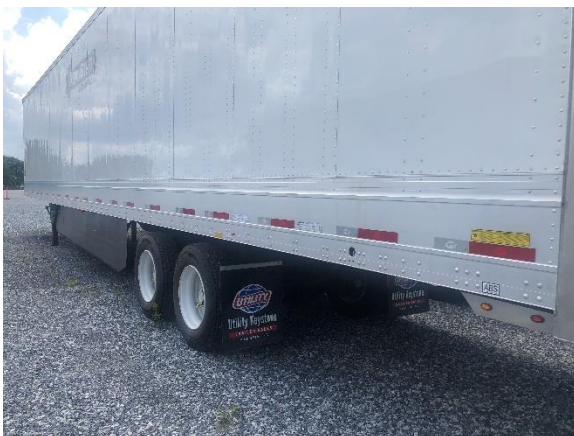
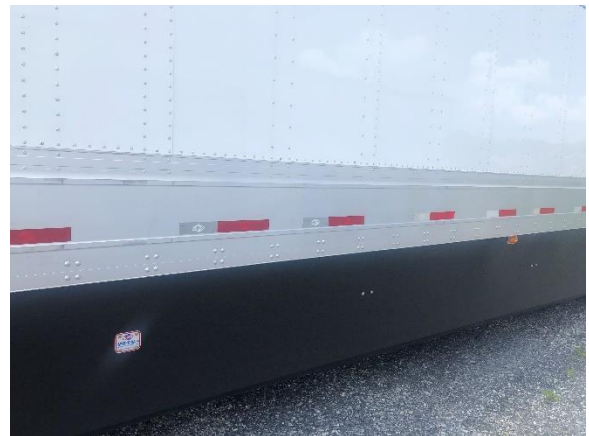
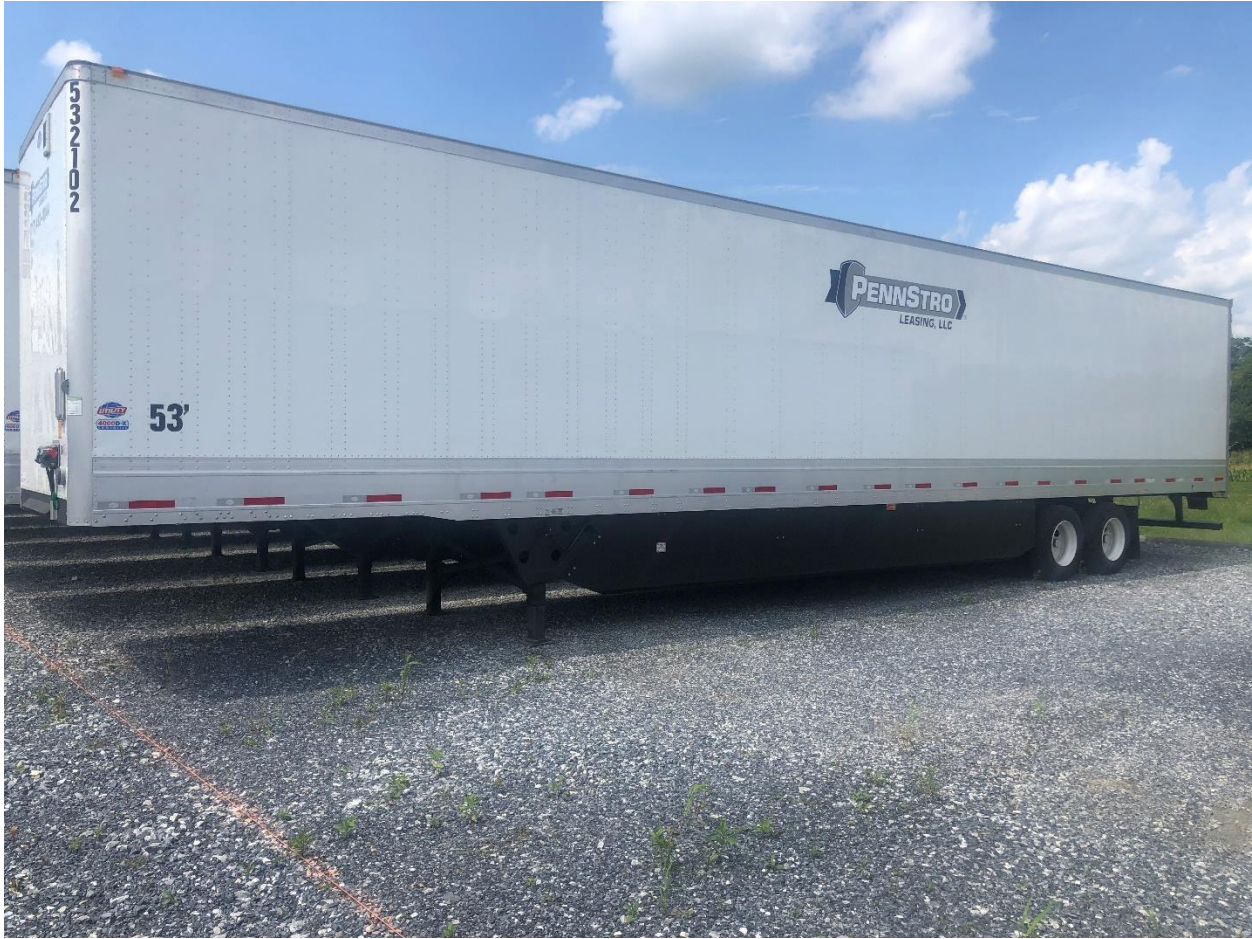
## TBR OEM Standards

**Note:** There are no patches, splices, or sections.
